ESS PURSUIT

SULFUR MUSTARD INCIDENT

New Bedford, MA - June 2010

Presented by: Andrew Jones, MassDEP – Emergency Response

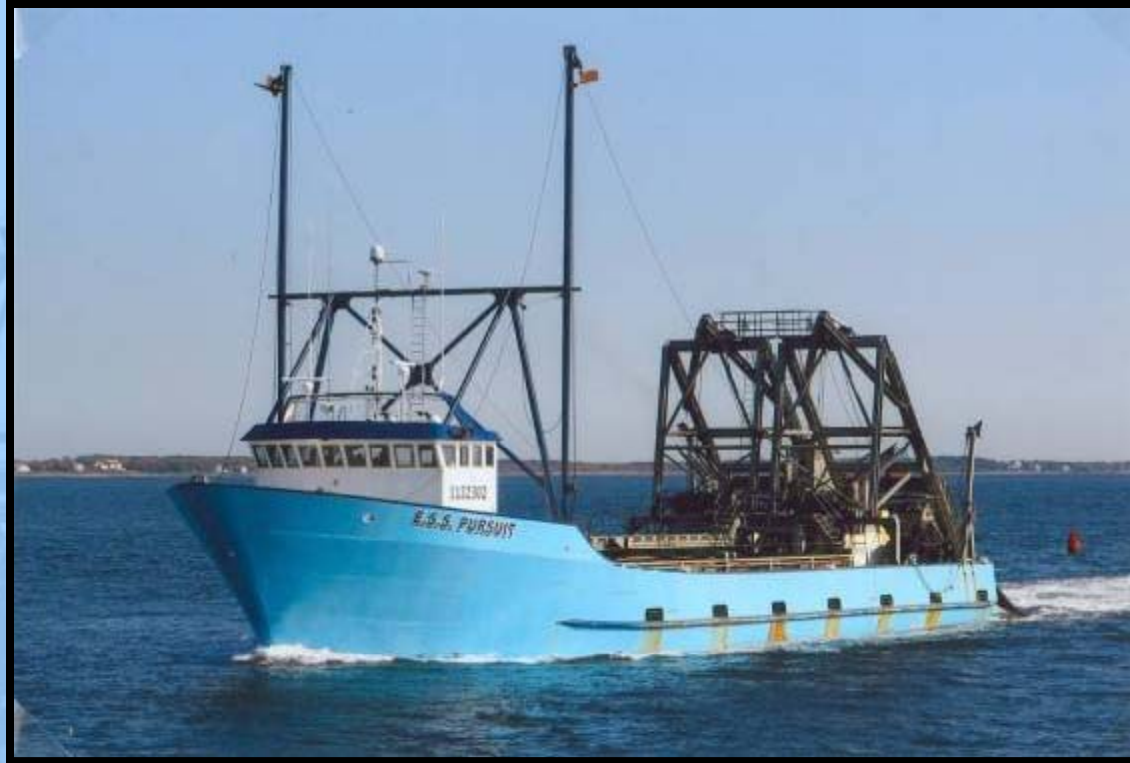
Type: Commercial Fishing Vessel

Typical Catch: Surf Clams/Mahogany Clams

Boat Length: 145.5 ft

Boat Gross Tons: 183.0

Boat Net Tons: 124.0

Vessel Build Year: 2002

Ship Builder: Duckworth Steel Boats

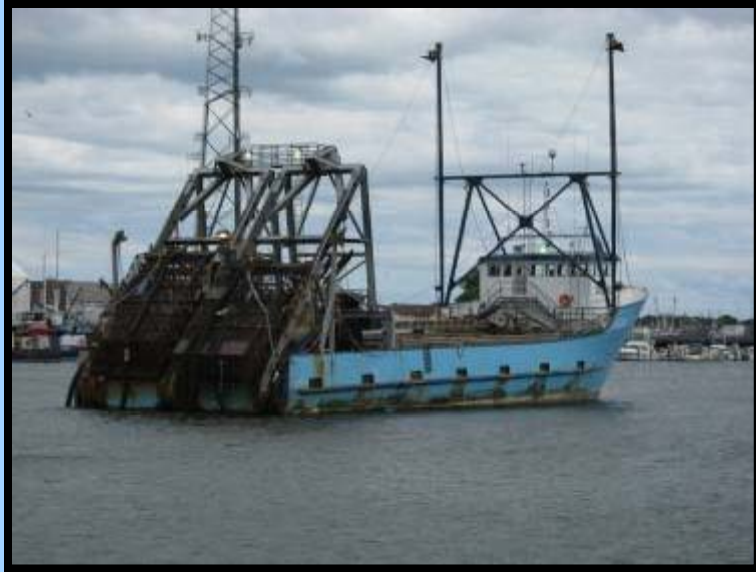
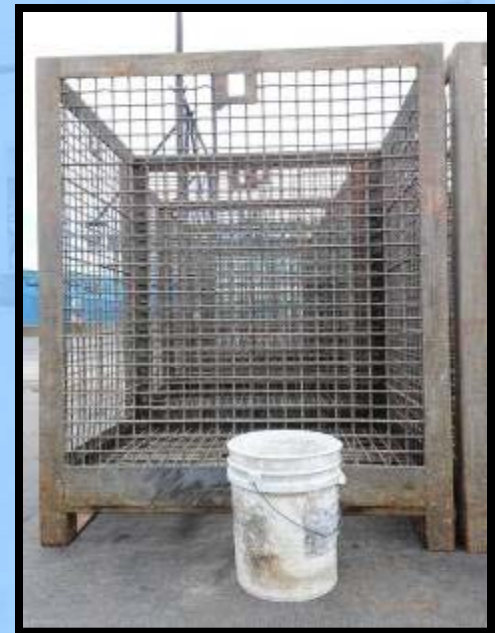
- Twin dredges collect clams from ocean bottom
- Dredges dump catch on sorting “table”
- Clams travel via conveyors to on-deck cages
- Cages/catch are stored on-deck
- Cages/catch continuously sprayed with refrigerated seawater until offloaded

- 180 clam cages aboard vessel
- Each cage measures 3’ x 4’ x 5’
- Up to 3,000 lbs of clams per cage (+/- 10%)
- A typical catch could be upwards of 540,000 lbs (unprocessed weight)

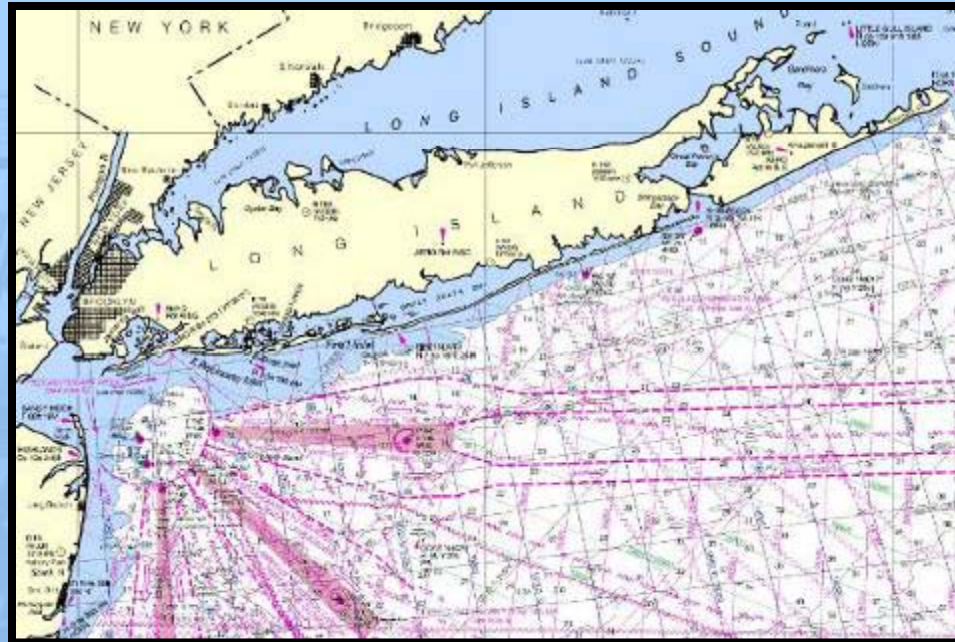
On Sunday, June 6, 2010, the fishing vessel E.S.S. Pursuit hauled up two WW-I era military munitions while dredging for clams off Long Island.

One munition broke apart on deck, causing one crewmember to be directly exposed to Sulfur Mustard.

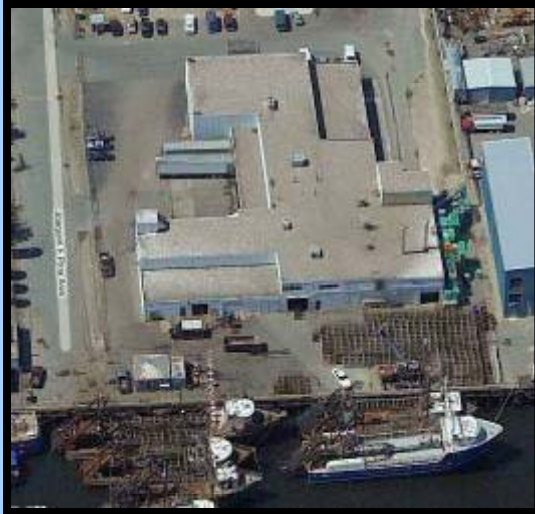
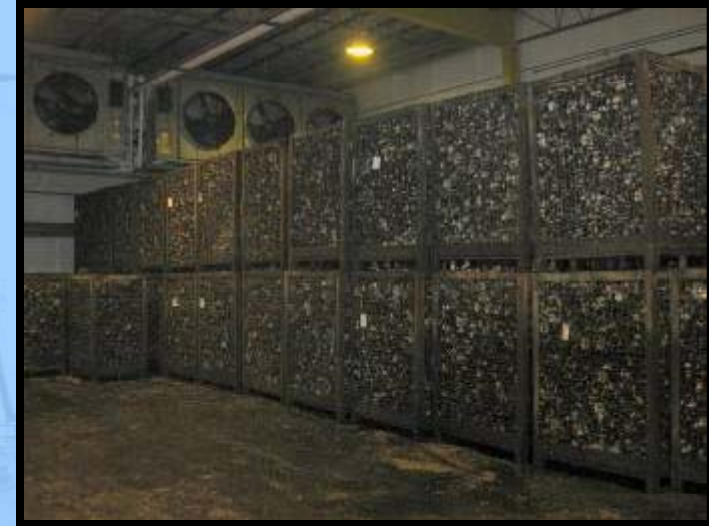
On Monday, June 7, 2010, the vessel and crew returned to port in New Bedford, MA. The catch was offloaded into a cooler at the SeaWatch International processing facility.

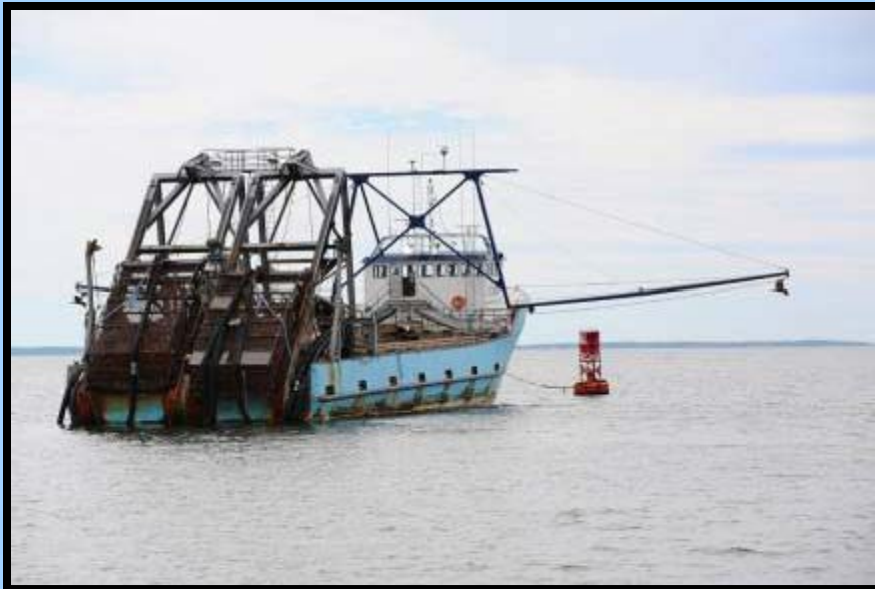
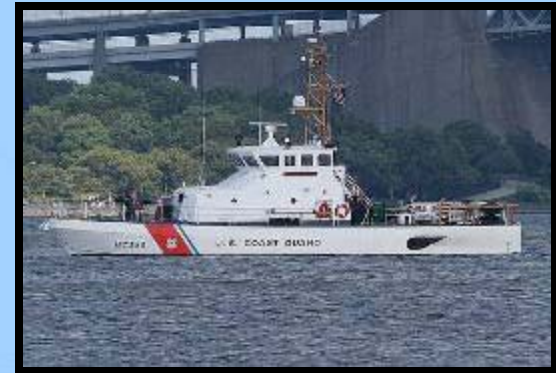
Per order of the USCG, the vessel was dispatched out of the port, and was directed to anchor just offshore of New Bedford in Buzzards Bay. The catch – assumed to be contaminated - was isolated and secured at the SeaWatch facility.

The Captain & First Mate remained aboard the vessel. The USCG Cutter “Tiger Shark” maintained a 500-foot security zone around the vessel.

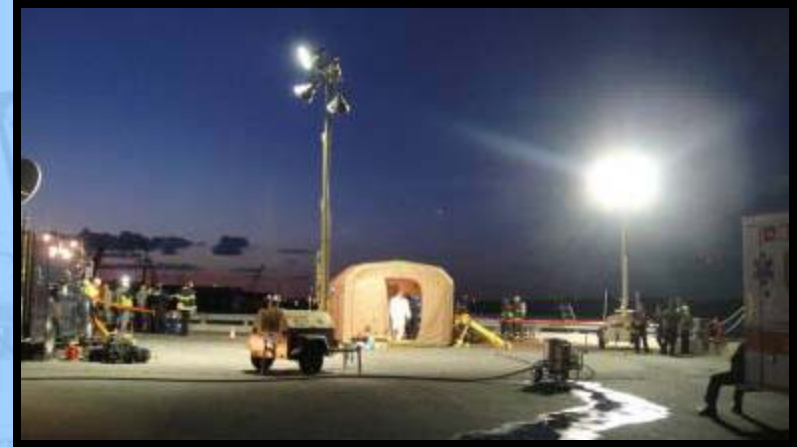
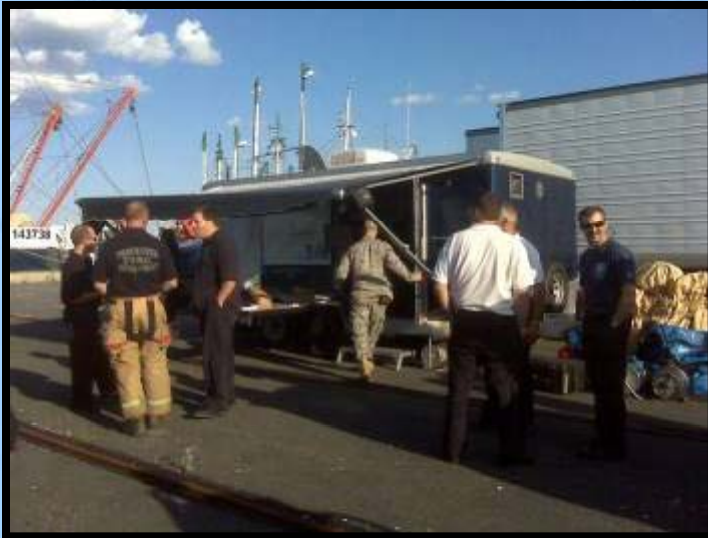
The Civil Support Team arrived at the site to begin recon and screening of the vessel. Decontamination areas were set up to decon personnel.

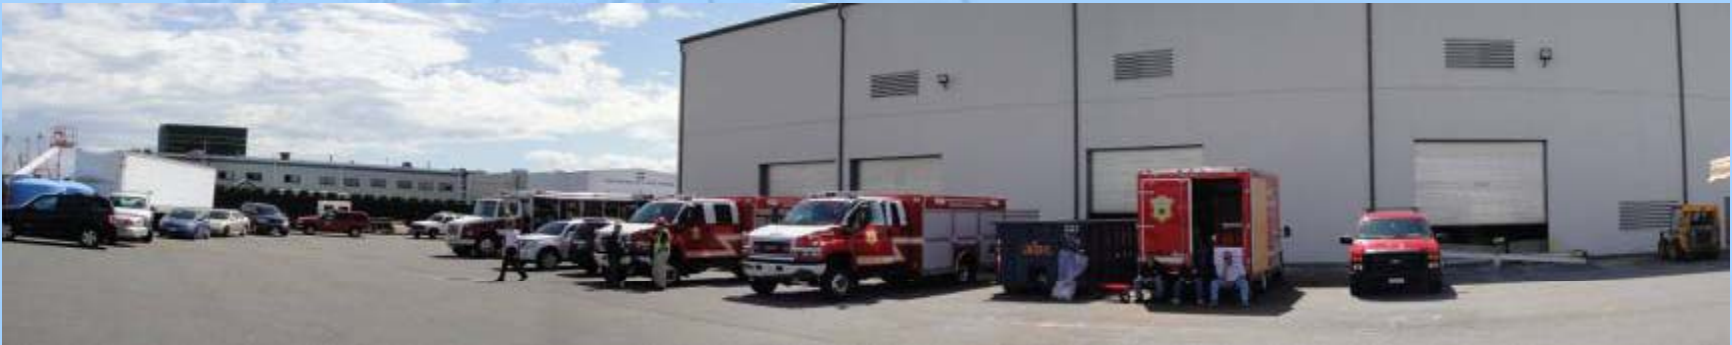
On Tuesday, June 8, 2010, the Massachusetts State Hazmat Team was dispatched to the Incident Command Post. The Hazmat Team performed an entry into the cooler to assess the catch. USCG & CST continued assessment of the ESS Pursuit.

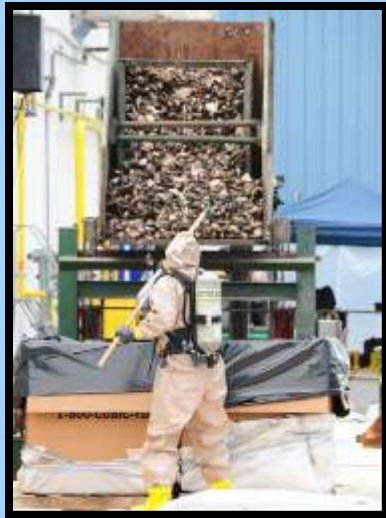
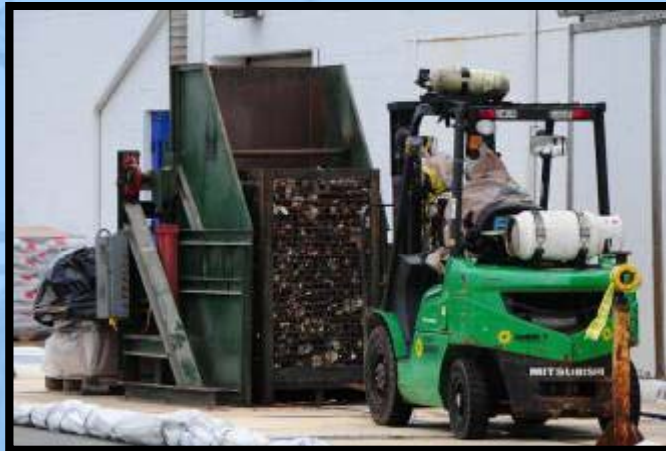
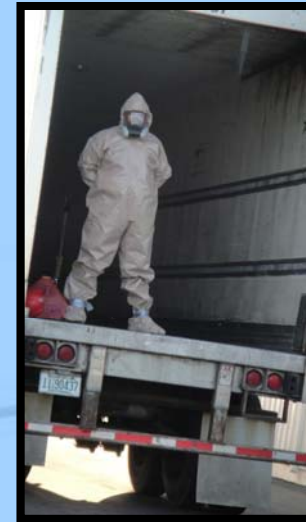
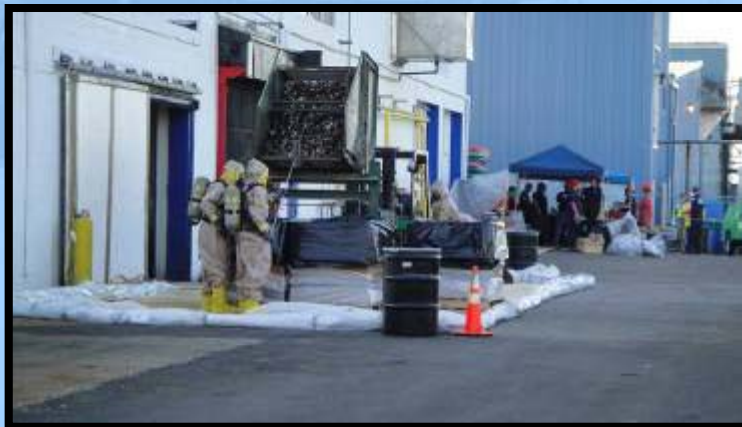
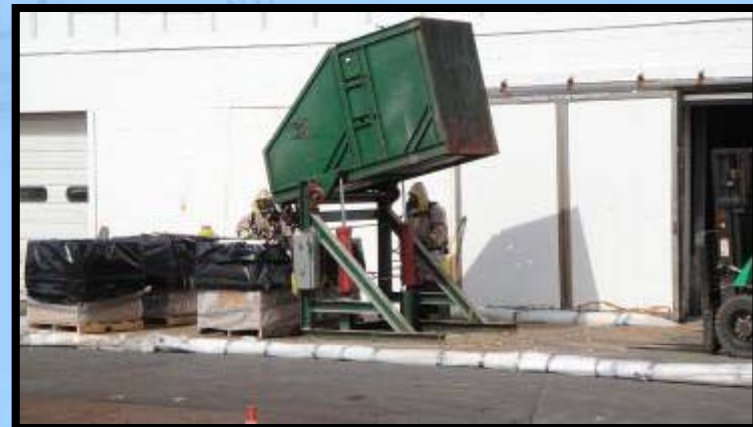
Clam Dumping Operation

As requested by Incident Command, MassDEP dispatched their Field Assessment and Support Team (FAST) to provide equipment and personnel for 24-hour assessment & monitoring during the clam dumping operation. AreaRae meters were deployed around the perimeter of SeaWatch International, and monitored for Hydrogen Sulfide and Ammonia.

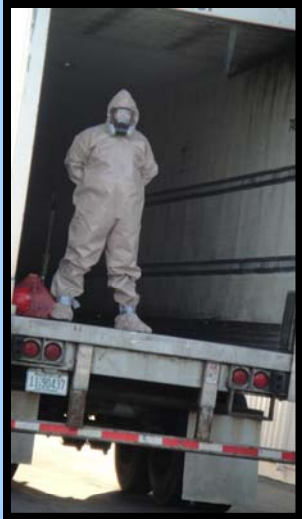
Trailer Decon Operation

A total of 486,897 pounds of clams were taken from the site to Clean Harbors incineration facilities in El Dorado, Arkansas and Deer Park, Texas.

After the loads were processed, the trailers were brought back to Massachusetts and Rhode Island, where they were decontaminated and sampled by USEPA and State CSTs.

At this time, one remaining trailer requires decon and sampling.
